# FOCUS *CR*

## FOOT TILT ADJUSTMENT GUIDE

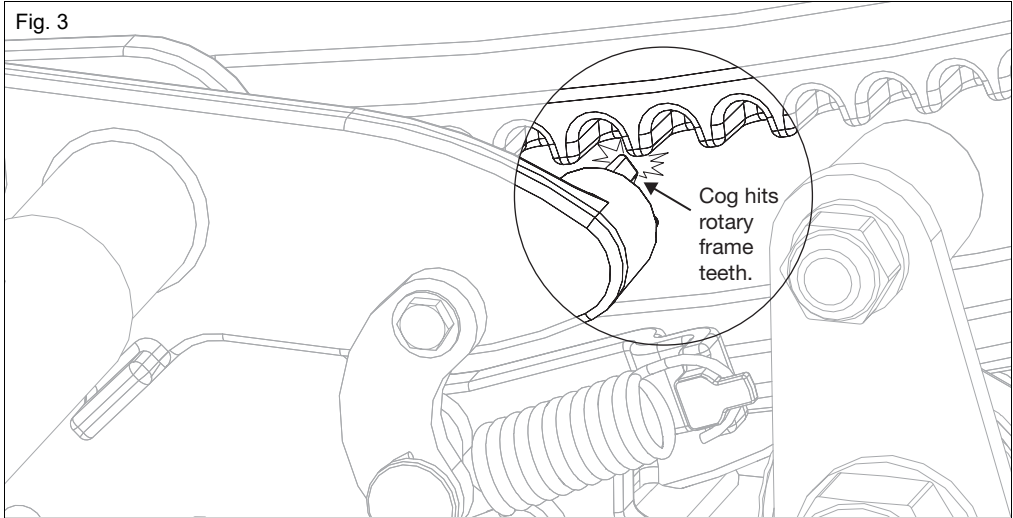
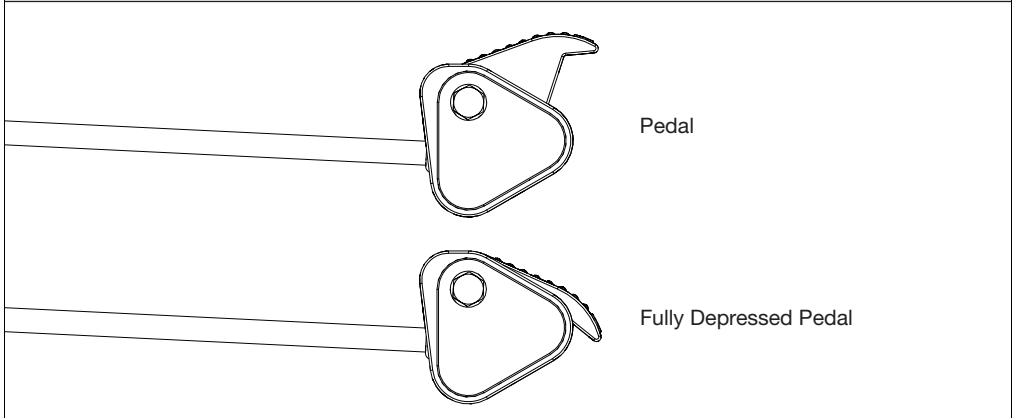
Fig. 3

## 1. Clicking Noise

A clicking noise is heard during the action of tilting the chair. This is caused by the cog not being fully retracted. Clicking is caused by incorrect shaft clamp placement or the foot pedal not being depressed fully. This may occur on one or both sides.

## A. Incorrect Shaft Clamp Placement

Before beginning adjustment, ensure tilt mechanism is locked and engaged. Adjust the locking clamp by loosening Allen head screw or hex bolt (C) on the shaft clamp (A) with either a 2.5mm Allen wrench or a 5.5mm wrench. Slide the shaft clamp up against the drive rod linkage (B) and retighten the shaft clamp. If clamp is slipping after adjusting and tightening, contact customer service.

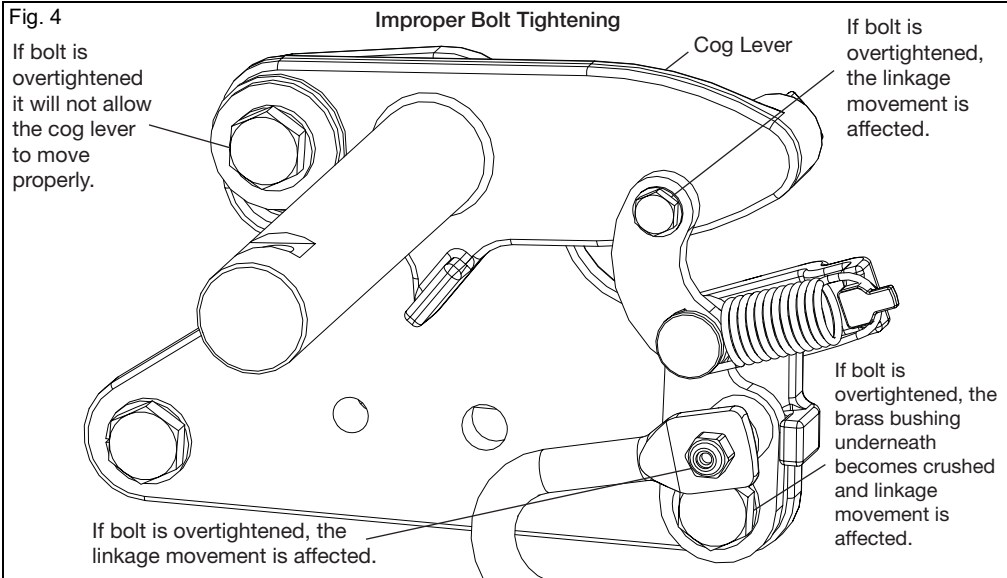
## 2. Tilt Not Locking / Difficulty Unlocking Tilt Mechanism

Chair may seem difficult to start and end the tilting process. It may take some wiggling to lock/unlock the tilt mechanism. This is caused by:

1. Improper bolt tightening (See Fig. 4 for image of issue. See Potential Solution - Section B for correcting)
2. Incorrect shaft clamp placement (See Fig. 5 for image of issue. See Potential Solution - Section A for correcting)
3. Improper drive insert issues (See Potential Solution - Section C for correcting)
4. COG adjustment being needed (See Potential Solution - Section D for correcting)

One side of the tilt mechanism may seem to catch and or not start/end tilt process as smoothly as the opposite side. This is caused by improper bolt tightening ((See Fig. 4 for image of issue. See Potential Solution - Section B for correcting) or improper drive insert issues (See Potential Solution - Section C for correcting).

## B. Improper Bolt Tightening

Bolts A, B, C and E should be tightened snug. Bolt D should be fully tightened. Inspect the following - nylon washers under bolt E ensuring washer is intact and linkage system is free moving. Release linkage spring and confirm. If it is stiff at the bottom linkage, replace brass bushing under bolt B. Also, check the tightness of bolt C if linkage movement is restricted. Also check bolts B, D and E on the opposite side. Replace any parts that appear crushed, cracked or broken.

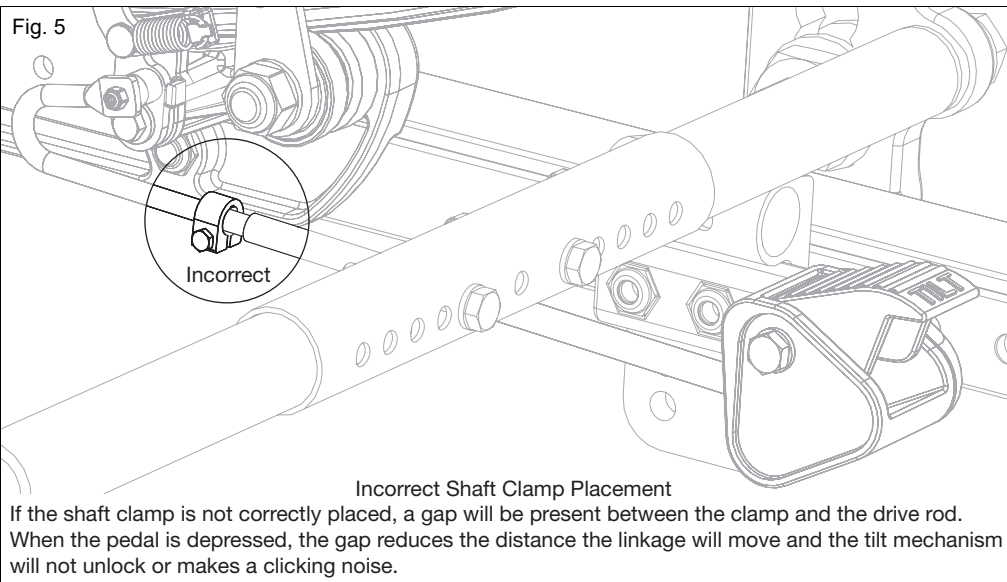
## 3. Tilt Mechanism Won't Lock / Locks Intermittently

The tilt mechanism may not lock at all or occasionally catches and locks. This could be caused by the drive rod being too slack (See Fig. 5 for image of issue. See Potential Solution - Section A for correcting) or improper bolt tightening (See Fig. 4 for image of issue. See Potential Solution - Section B for correcting).
