# FOCUS *CR* & *CRe*

HAND TILT ADJUSTMENT GUIDE

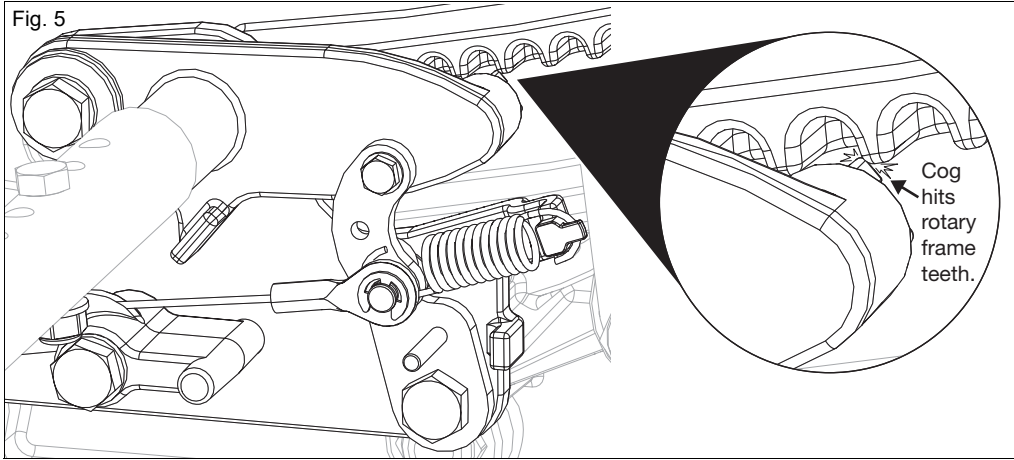
Fig. 5

A clicking noise is heard during the action of tilting the chair. This is caused by the cog hitting the rotary frame teeth as the chair tilts. Clicking is caused by the cable being too loose or the trigger(s) not being engaged fully. This may occur on one or both sides.

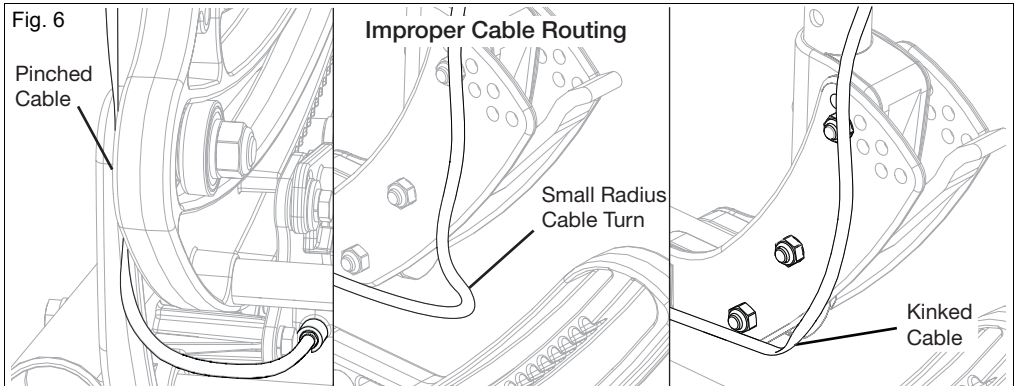
Fig. 6

There are different points on the chair where the tilt cable may become pinched, kinked or have too tight of turns (small radius cable turn) which causes friction.

Correct any pinch points, tight turns (small radius cable turn) or kinks. Proper cable routing will help prevent cable issues. Before correcting any cable issues, always check the condition of the cable and replace if damaged.

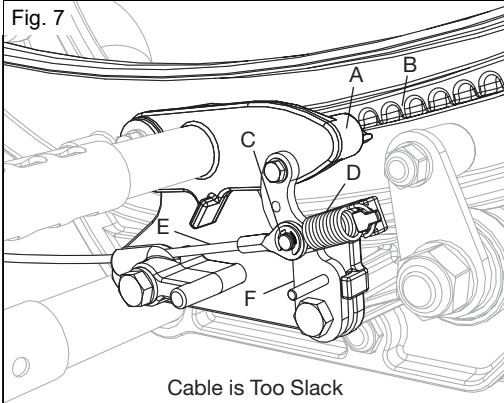
Fig. 7

Cable is Too Slack

When cable adjuster is too short, cable (E) is too long, the tilt mechanism is not fully actuated at the pivot point (C). The spring (D) is not overcome and the linkage (F) does not pull the cog (A) down and out of the rotary frame teeth (B).

Loosen the jam nut (A). Hold the top portion of cable adjustment hardware and turn the adjuster (B) clockwise to remove slack and counterclockwise to increase slack. The trigger should move no more than 1/8" before pulling the cable (F) and linkage (C and H). The lower linkage (H) should also rest against the tilt stop (I) with the cog (D) engaged in the rotary frame teeth (E). Test the levers after each adjustment to ensure levers engage properly and tilt mechanism releases and locks. Tighten jam nut.

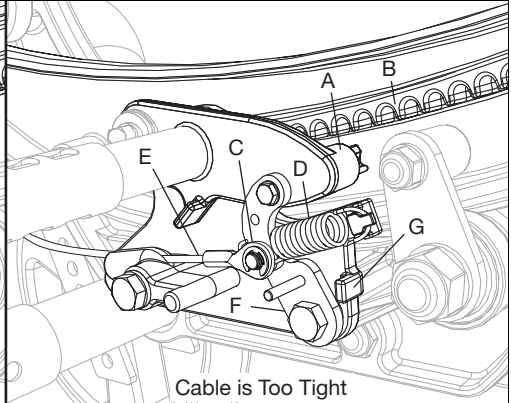
Cable is Too Tight

When cable adjuster is too long, cable (E) is too tight, the tilt mechanism does not fully lock and the linkage (F) does not rest against the tilt stop (G). This prevents the cog (A) from fully engaging into the rotary frame teeth (B).

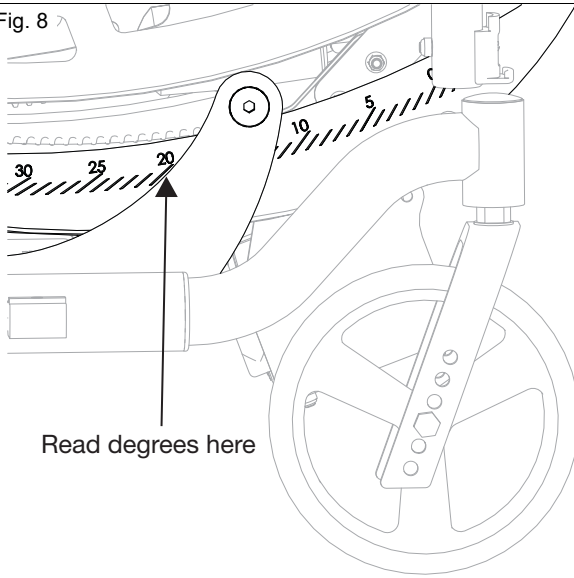
Fig. 8

Improper COG settings will result in a reading that falls outside the acceptable range and will cause difficulty in initiating tilt. Lock wheel locks (if equipped). Place occupant in chair with all equipment that attaches to upper frame, such as foot boxes, backpacks, etc. Squeeze triggers or depress foot pedal and allow rotary frame to find its resting place. The tilt angle degree reading should be between 17° and 23°.

- Remove the seat frame position locking screws (Fig. 17:B) using a 5mm Allen wrench.
- If resting angle is larger than 23°, pull seat frame toward the front of the chair until approximate 20° resting angle is achieved. If frame rests at an angle smaller than 17°, push seat frame toward the rear until approximate 20° is achieved.
- Different occupants will respond differently, but a good starting point is to move the seat frame ½" for every 5° that the angle is off from 20°.
- Once optimum position is achieved, reinstall and tighten positioning screws in holes closest to optimum position. Screws may be placed in front or rear hole of seat frame saddle (Fig. 17:A).

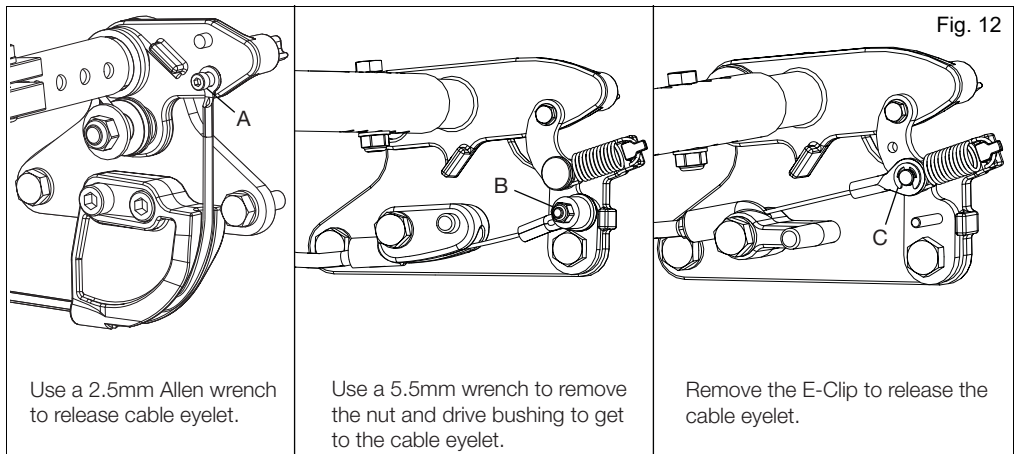
**NOTE:** If cable adjustment solution does not resolve issue - Sometimes a damaged or binding cable jacket will show symptoms similar to cable routing or cable adjustment issues. Check the cable for hidden or undiscovered damage, remove the screw (A), nut (B) or E-Clip (C) (depending on your revision of tilt mechanism) and release the cable eyelet (A) from the tilt mechanism. The tilt trigger should be able to be moved freely without any resistance. If there is resistance, the jacket is kinked and/or is binding. Replace cable if you are unable to correct through proper cable routing and inspection.
