# FOCUS *CR*

## FOOT TILT ADJUSTMENT GUIDE

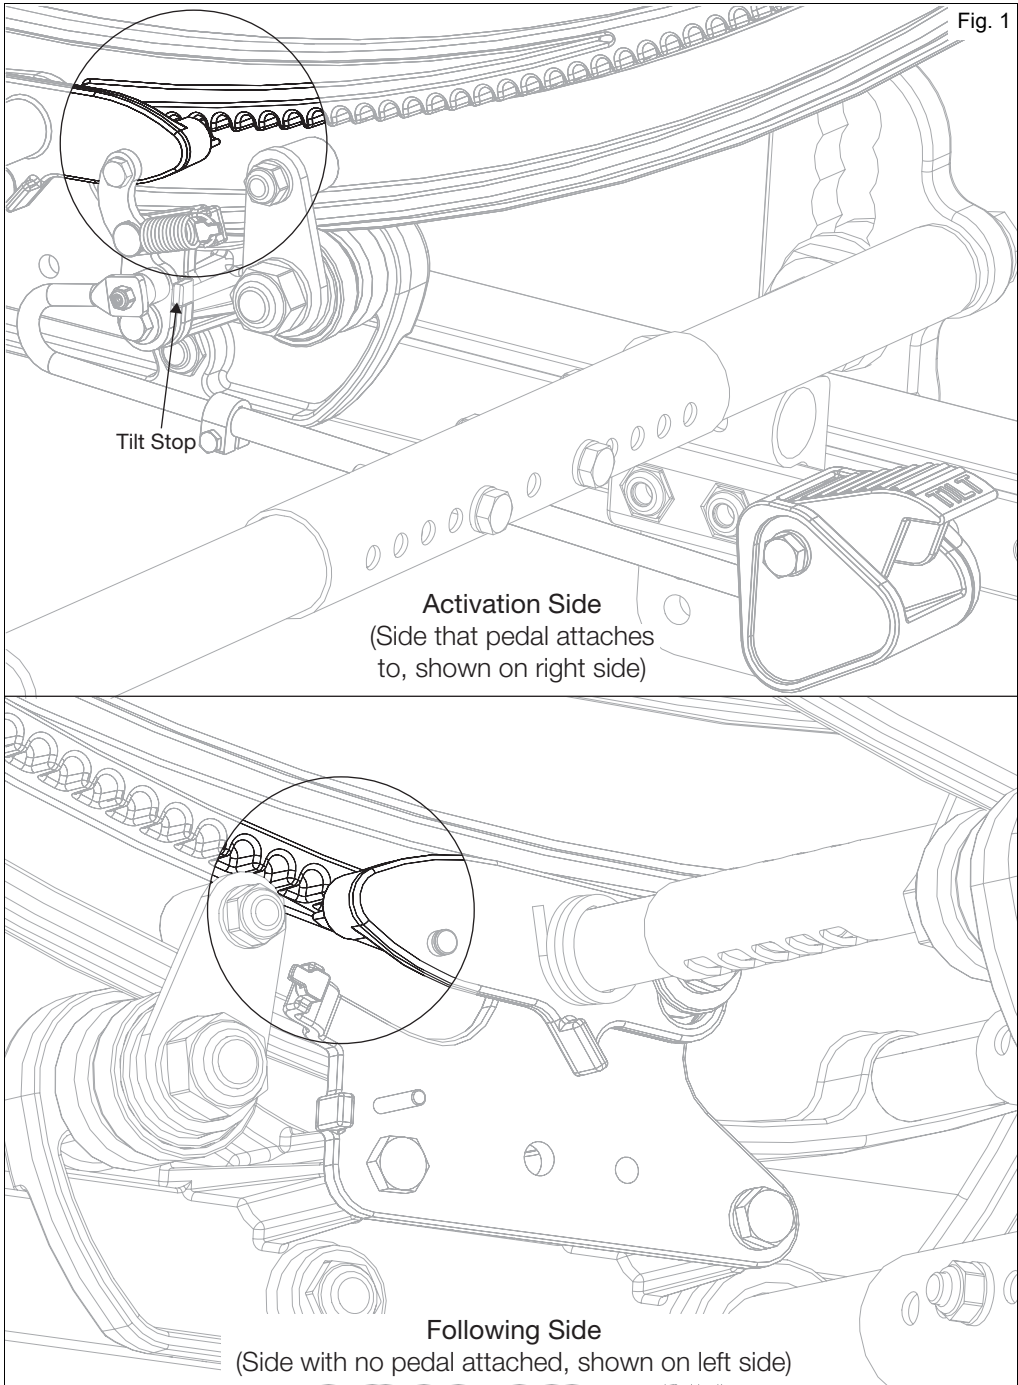
# Objective - Foot Tilt (Locked)

Lower linkage is locked and rests against the tilt stop. Linkage cannot move. Cog is engaged in the rotary frame teeth. Tilt system is locked.

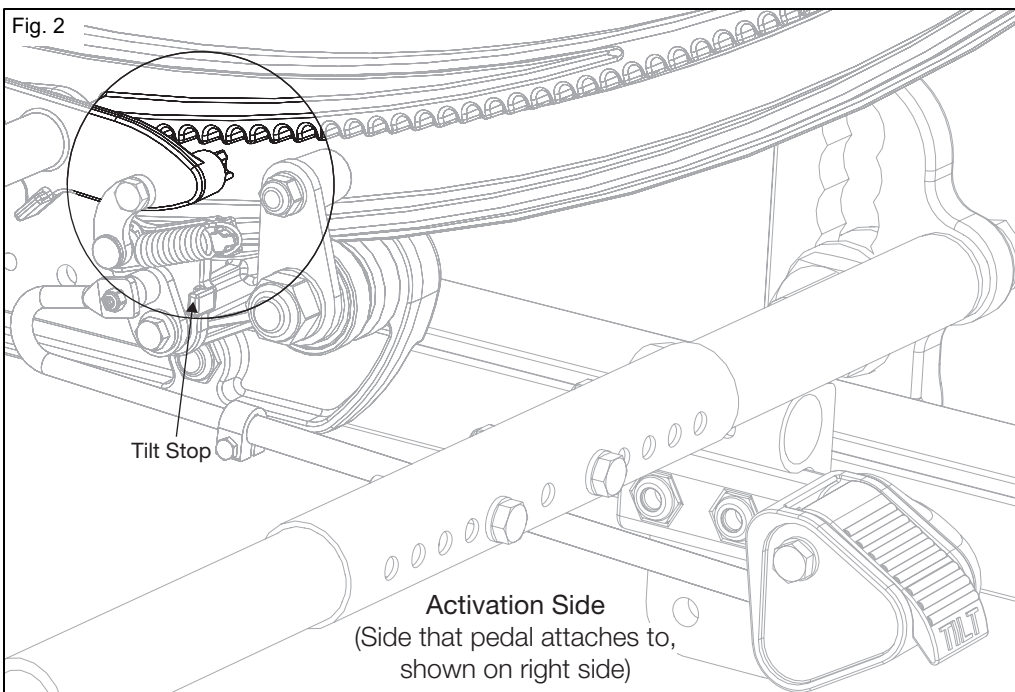
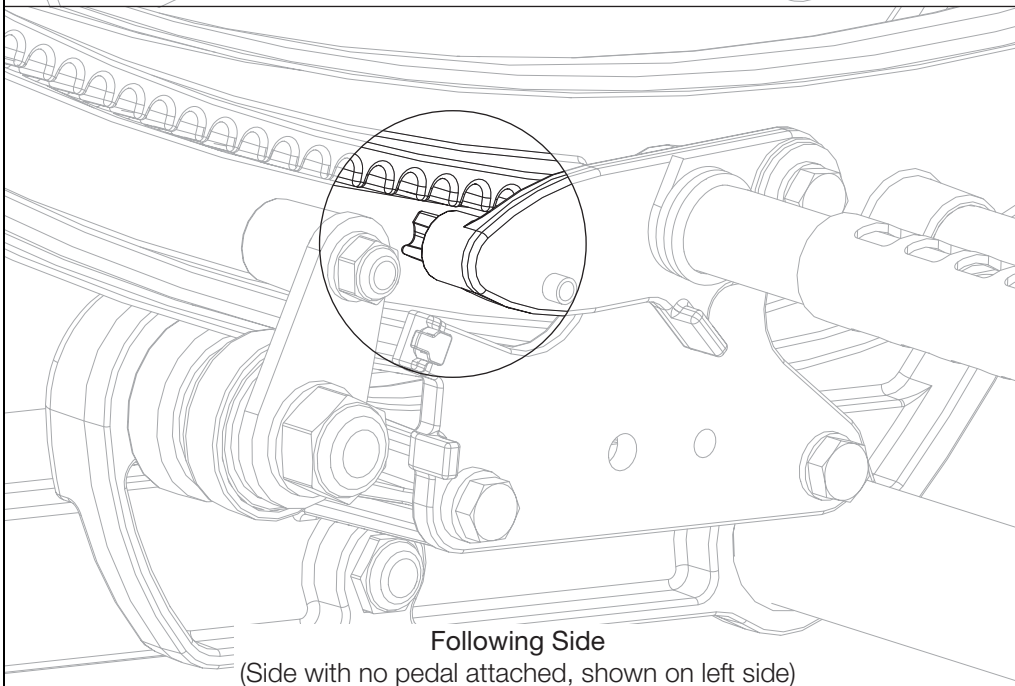
Fig. 2

When foot pedal is depressed, the foot linkage rod pulls the pivot point and spring is overcome allowing linkage to pull the cog down and disengage from the rotary frame teeth. Note the lower linkage is pulled away from the tilt stop. Tilt system is unlocked, cog has clearance from teeth.
