CLINICAL CASE REPORT

CARLOS KRAMER, HEAD OF EDUCATION VICAIR,
THE NETHERLANDS

Accommodating differences in mass with a Vicair Vector O2

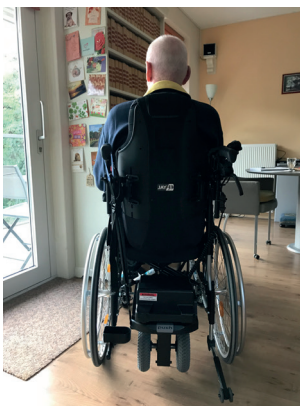
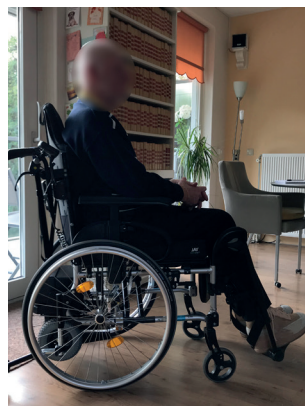
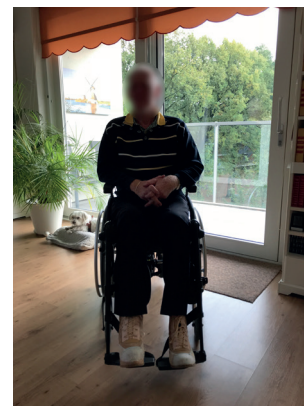
Figure 1,2,3: Situation at the start of the case

This case report focuses on the importance of proper positioning and creating stability when there needs to be dealt with a difference in body mass in the seating surface, even pressure distribution is also of importance to safeguard skin integrity in an asymmetric position. Polio affected mr. R's right leg which can both be observed in the difference in length and muscle mass. There's a 4cm difference in circumference between the right and the left leg just above the knee. Due to this difference in muscle mass, mr. R is always positioned slightly crooked.

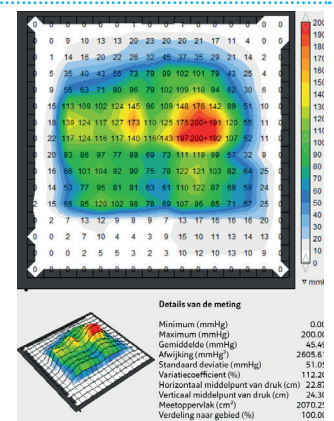
Figure 4: Pressure map Jay Easy Visco

In his current set up he also feels that he slides forward in his chair, indicating unstable positioning. In addition he indicates being uncomfortable and not being able to sit in his chair all day and feels fatigued. The crooked position is confirmed when we conduct a pressure mapping measurement. As can be seen in figure 4 there's a clear difference in pressure between the two sides. More pressure on his left leg could possibly also be the cause of the discomfort that he describes.

Mr. R. showed us two cushions, one that was a standard cushion delivered with the wheelchair that has never really been used. This to the fact that this was never prescribed as a flat cushion could never support the asymmetry in his body. In response to this demand mr. R received an Jay Easy Visco to better fit his needs for a contoured cushion. The pressure map displayed in figure 1 shows the situation when mr. R was seated on the Jay Easy Visco, hence his problem was not solved with this contoured cushion.

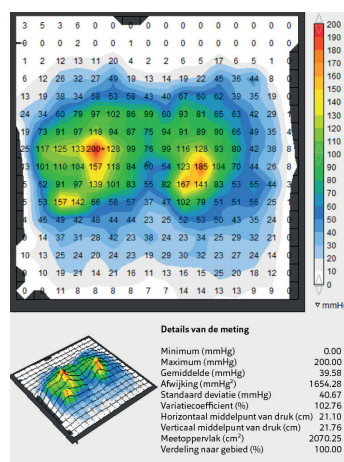
Figure 5: Pressure map Vicair VectorO2

expected, some adjustments needed to be made. The images show the differences in pressure between the Vicair Vector O2 in its standard configuration and the adjusted version.

The pressure maps show that the pressure has been significantly been decreased. The unadjusted Vector O2 was already an improvement in comparison to the Jay Easy Visco. The adjusted VectorO2, however, shows even more pressure improvement and we can now also see the leg support the cushion provides represented on the pressure map. Cells were added on the right side of the cushion to accommodate for the missing mass and a number of cells were taken out on the left where the normal leg is positioned. Figure 7 shows the adjust filling grade of mr. R's Vector O2.

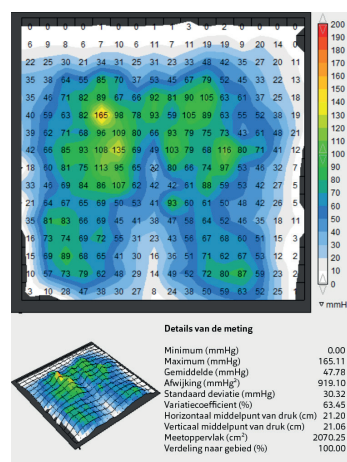
Figure 6: Pressure map adjusted Vicair VectorO2

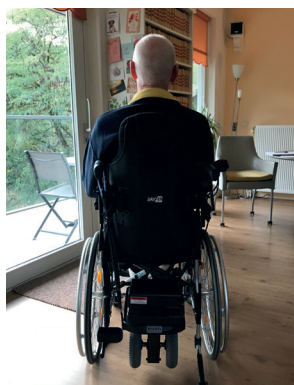
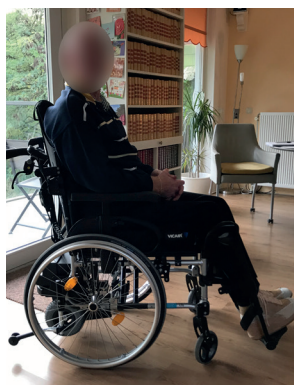
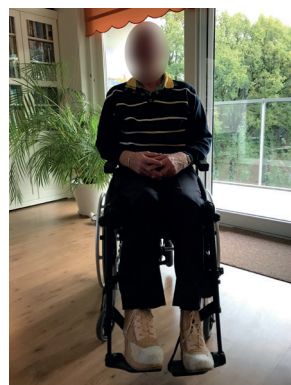
Figure 8,9,10: Situation at the end of the case

Immediately after the adjustment we can observe an improvement in mr. R's position. It was easily spotted by the line of his shoulders that is now positioned straight. He also immediately indicates that he feels more supported. A longer testing period should point out of the cushion also delivers the desired results for the long term.

After about a month of testing mr. R is still positioned nicely straight in his wheelchair on the adjusted cushion. He however indicates that he has a new fitting shoe for his AFO and received new leg supports for his wheelchair. His seating set up has therefore changed a bit but he has easily adjusted the cushion with adding and removing a number of single cells in compartments. This does however indicate that a different AFO has influence on his positioning and therefore new shoes in the future might further affect his position in the wheelchair.

The combination of his new shoes and feet supports created a higher positioning of the thighs and it was therefore decided to create a foam wedge under the front of the cushion to make up for the distance that has been created and re-establish the support on the legs fully. This would be a temporary solution as the arrival of his new AFO might change the situation again.
